# Walk Around

## Focke-Wulf Fw 190A/F

Walk Around Number 22  
squadron/signal publications

By Malcolm Laing and E. Brown Ryle

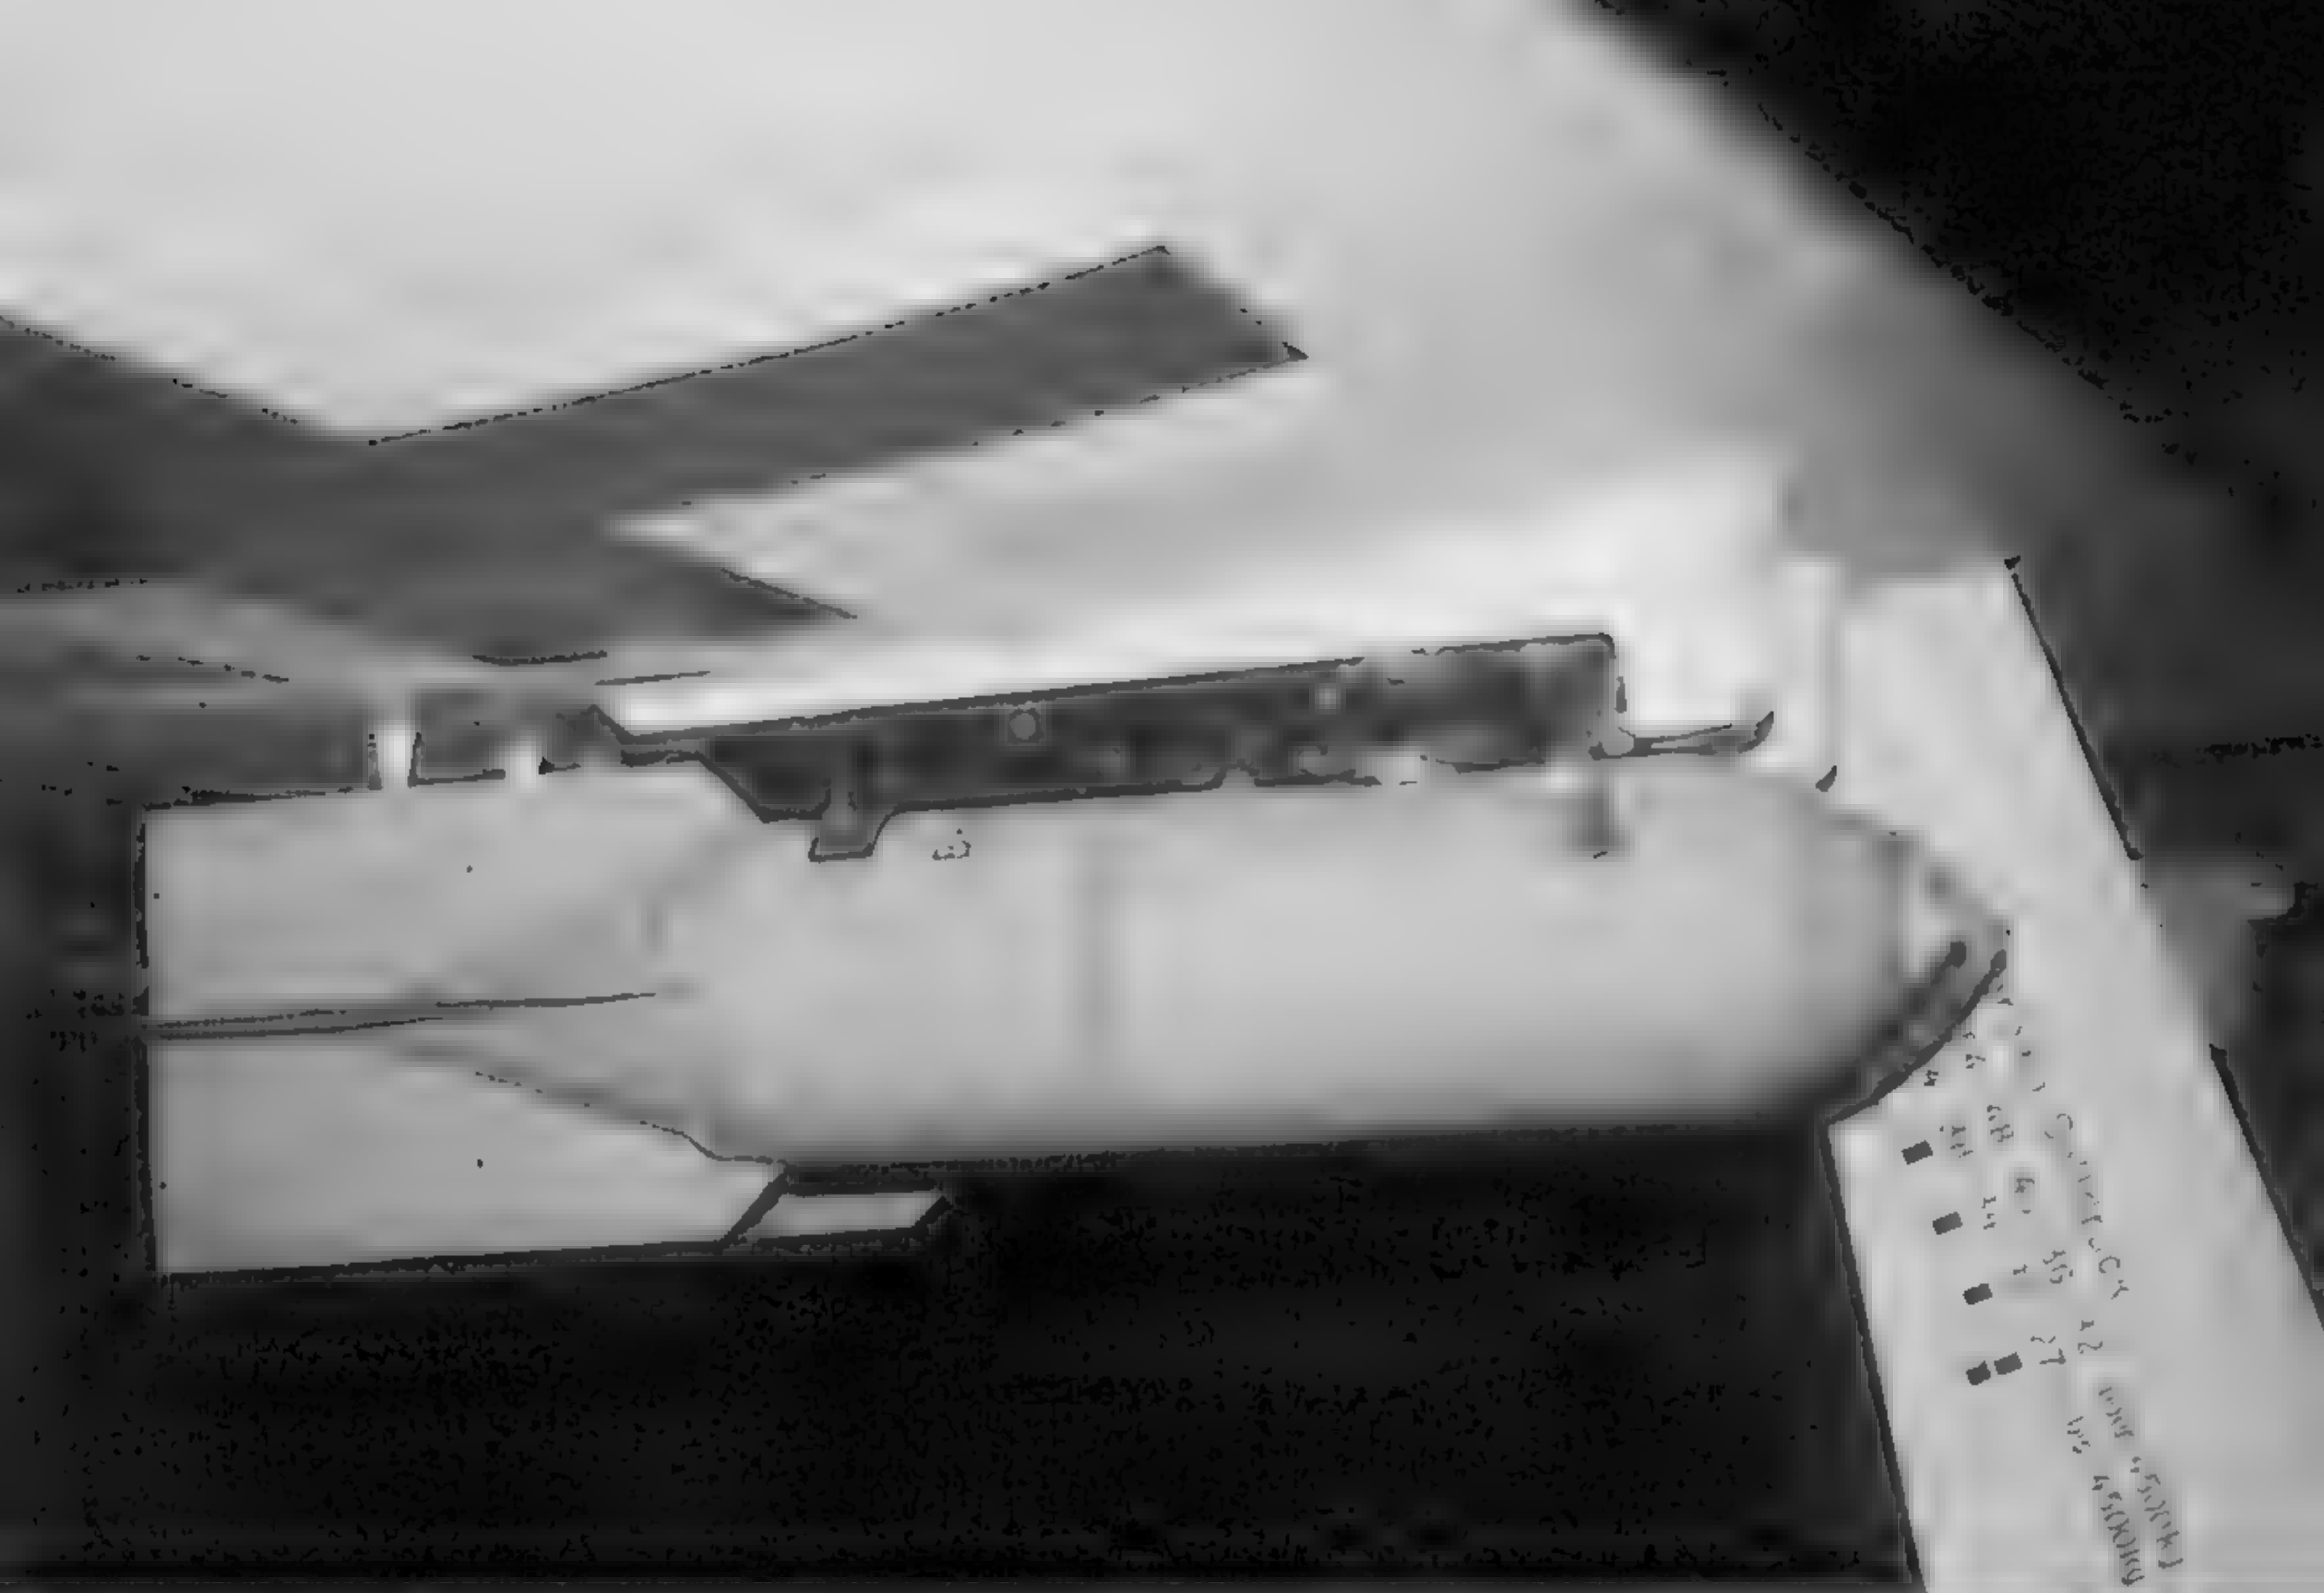
A 110.2 pound (50 kg) SC50 bomb is mounted on each of the two ETC 50 bomb racks under the Fw 190F-8's starboard wing. The two racks are located just outboard of the main gear, close to the leading edge of the wing. Two additional ETC 50 racks are located under the port wing. (Ryle)

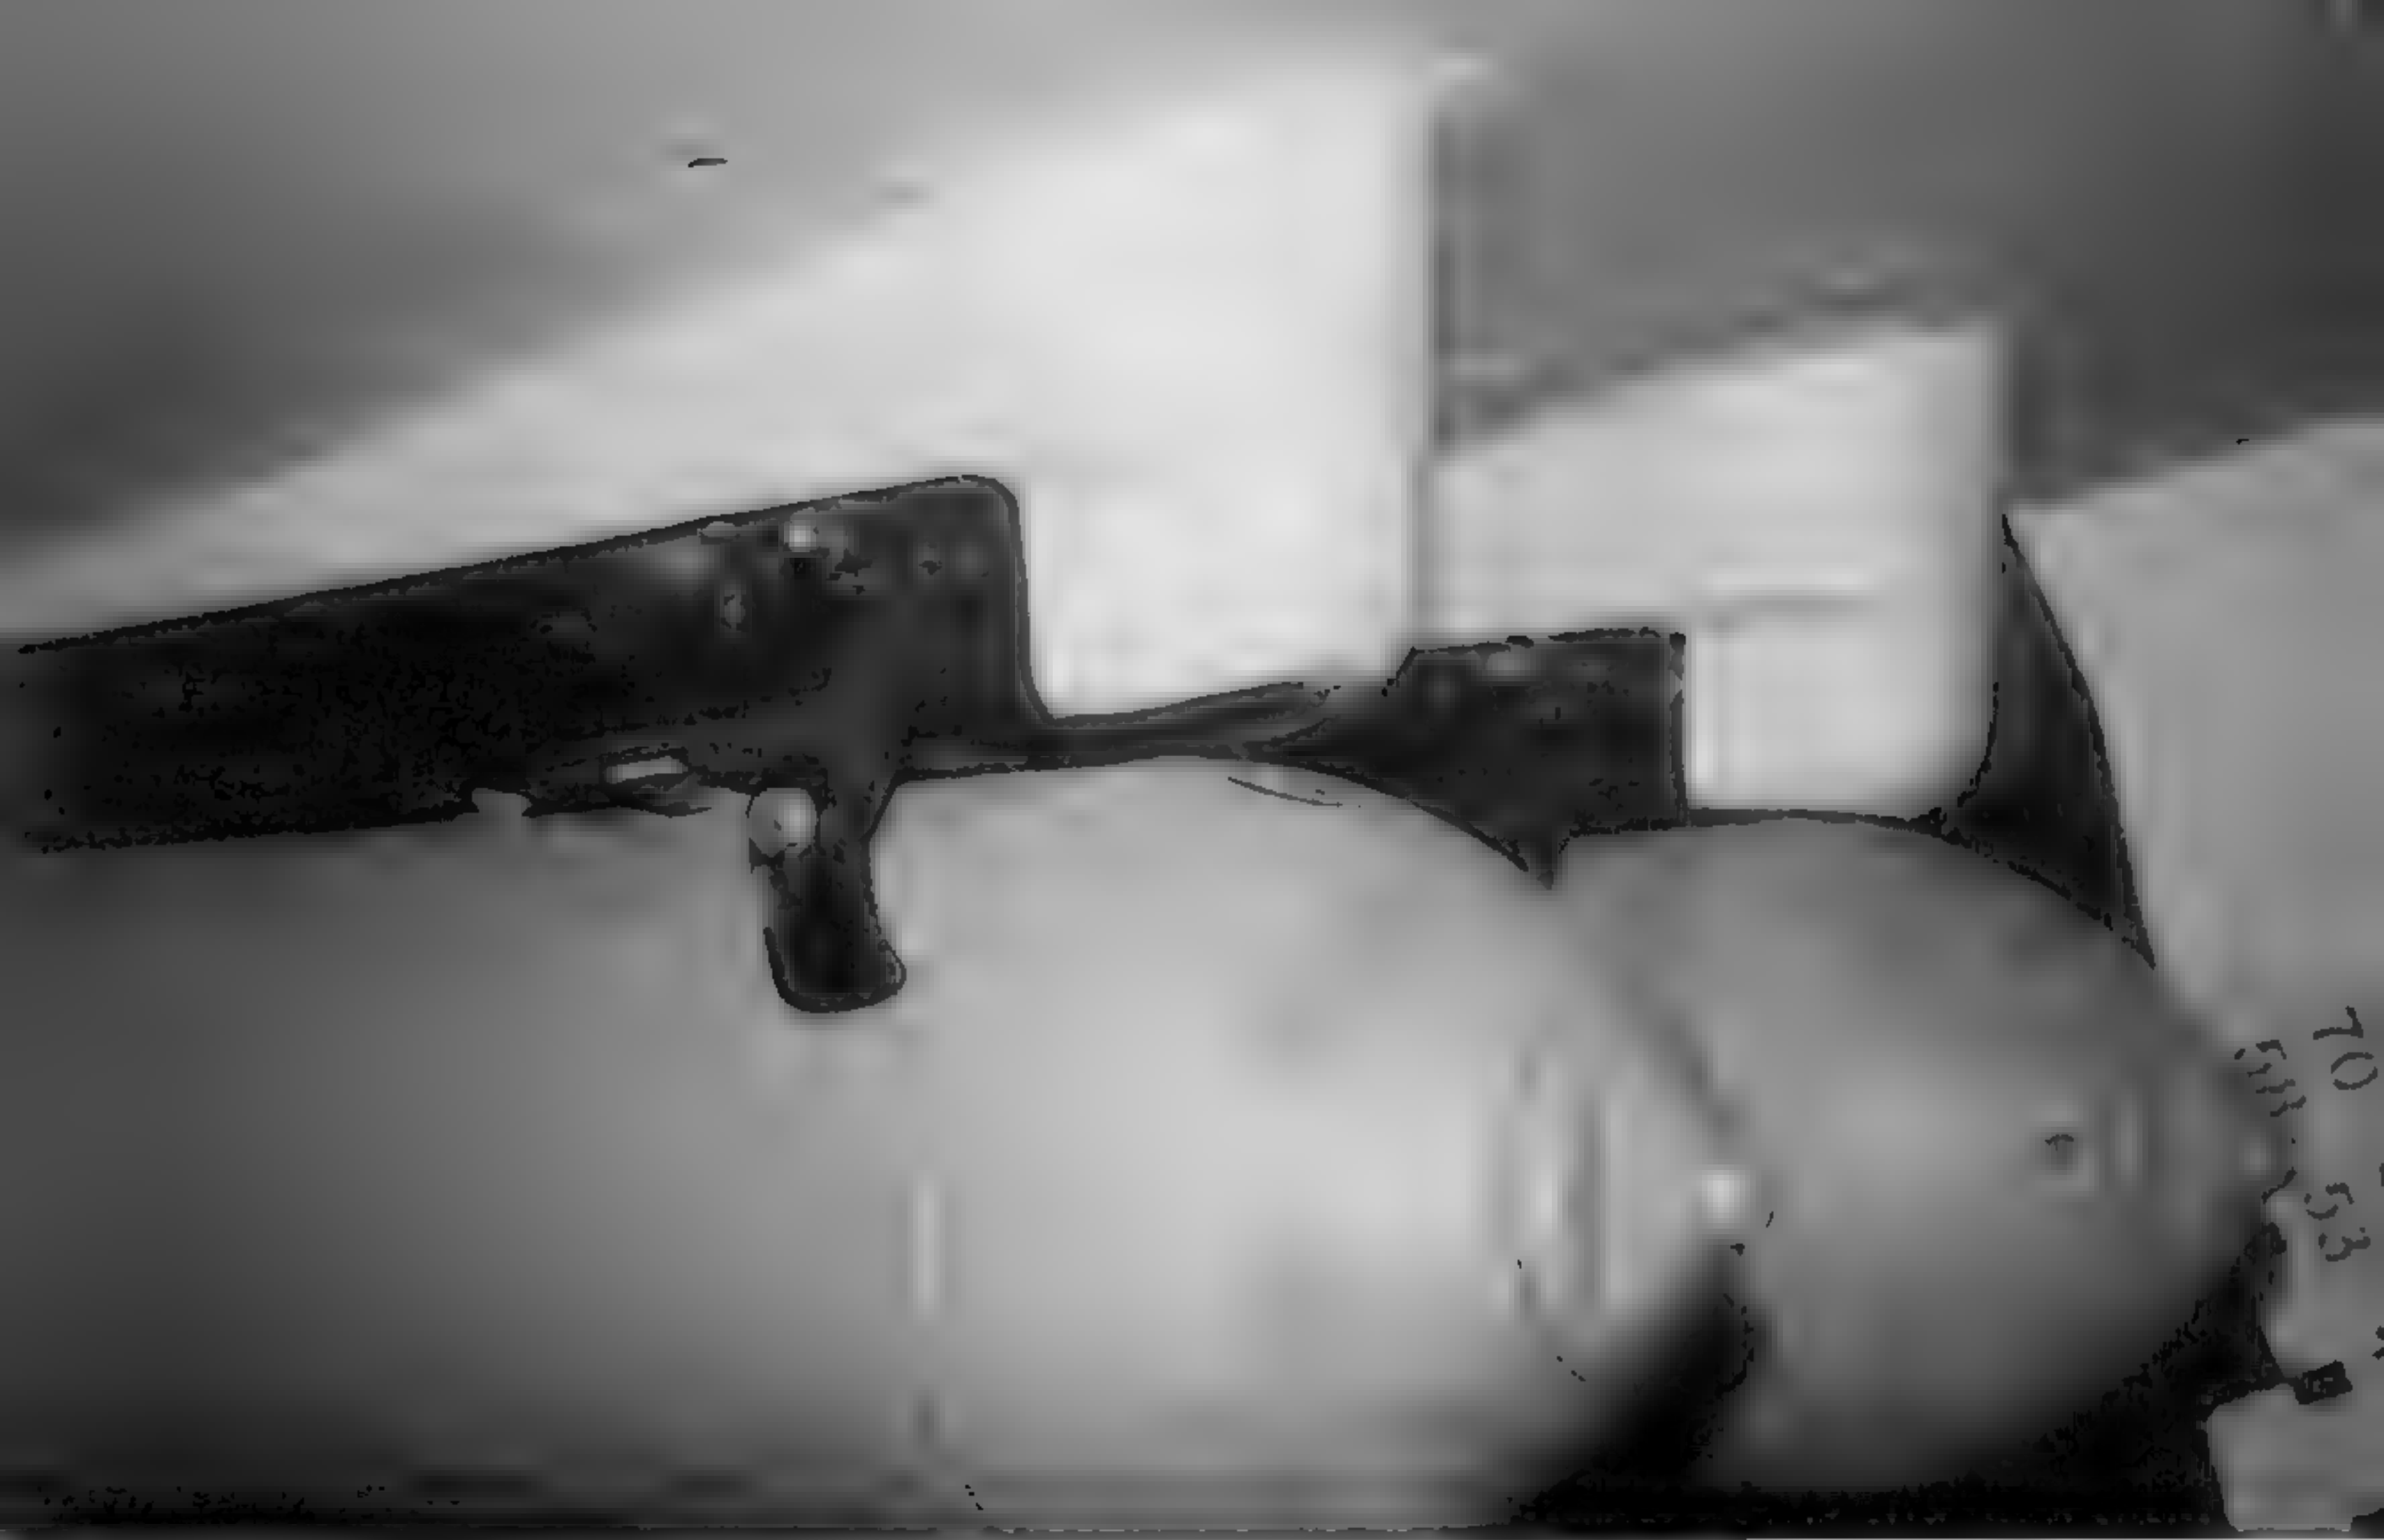
The ETC 50 fairing was a late World War II design welded together from four different stamped metal pieces. Many late-war Luftwaffe aircraft parts relied heavily on the use of welding in their manufacture, due to the low time and skill requirements of this process. The bombs are painted brown with a red stripe on the nose. (Ryle)

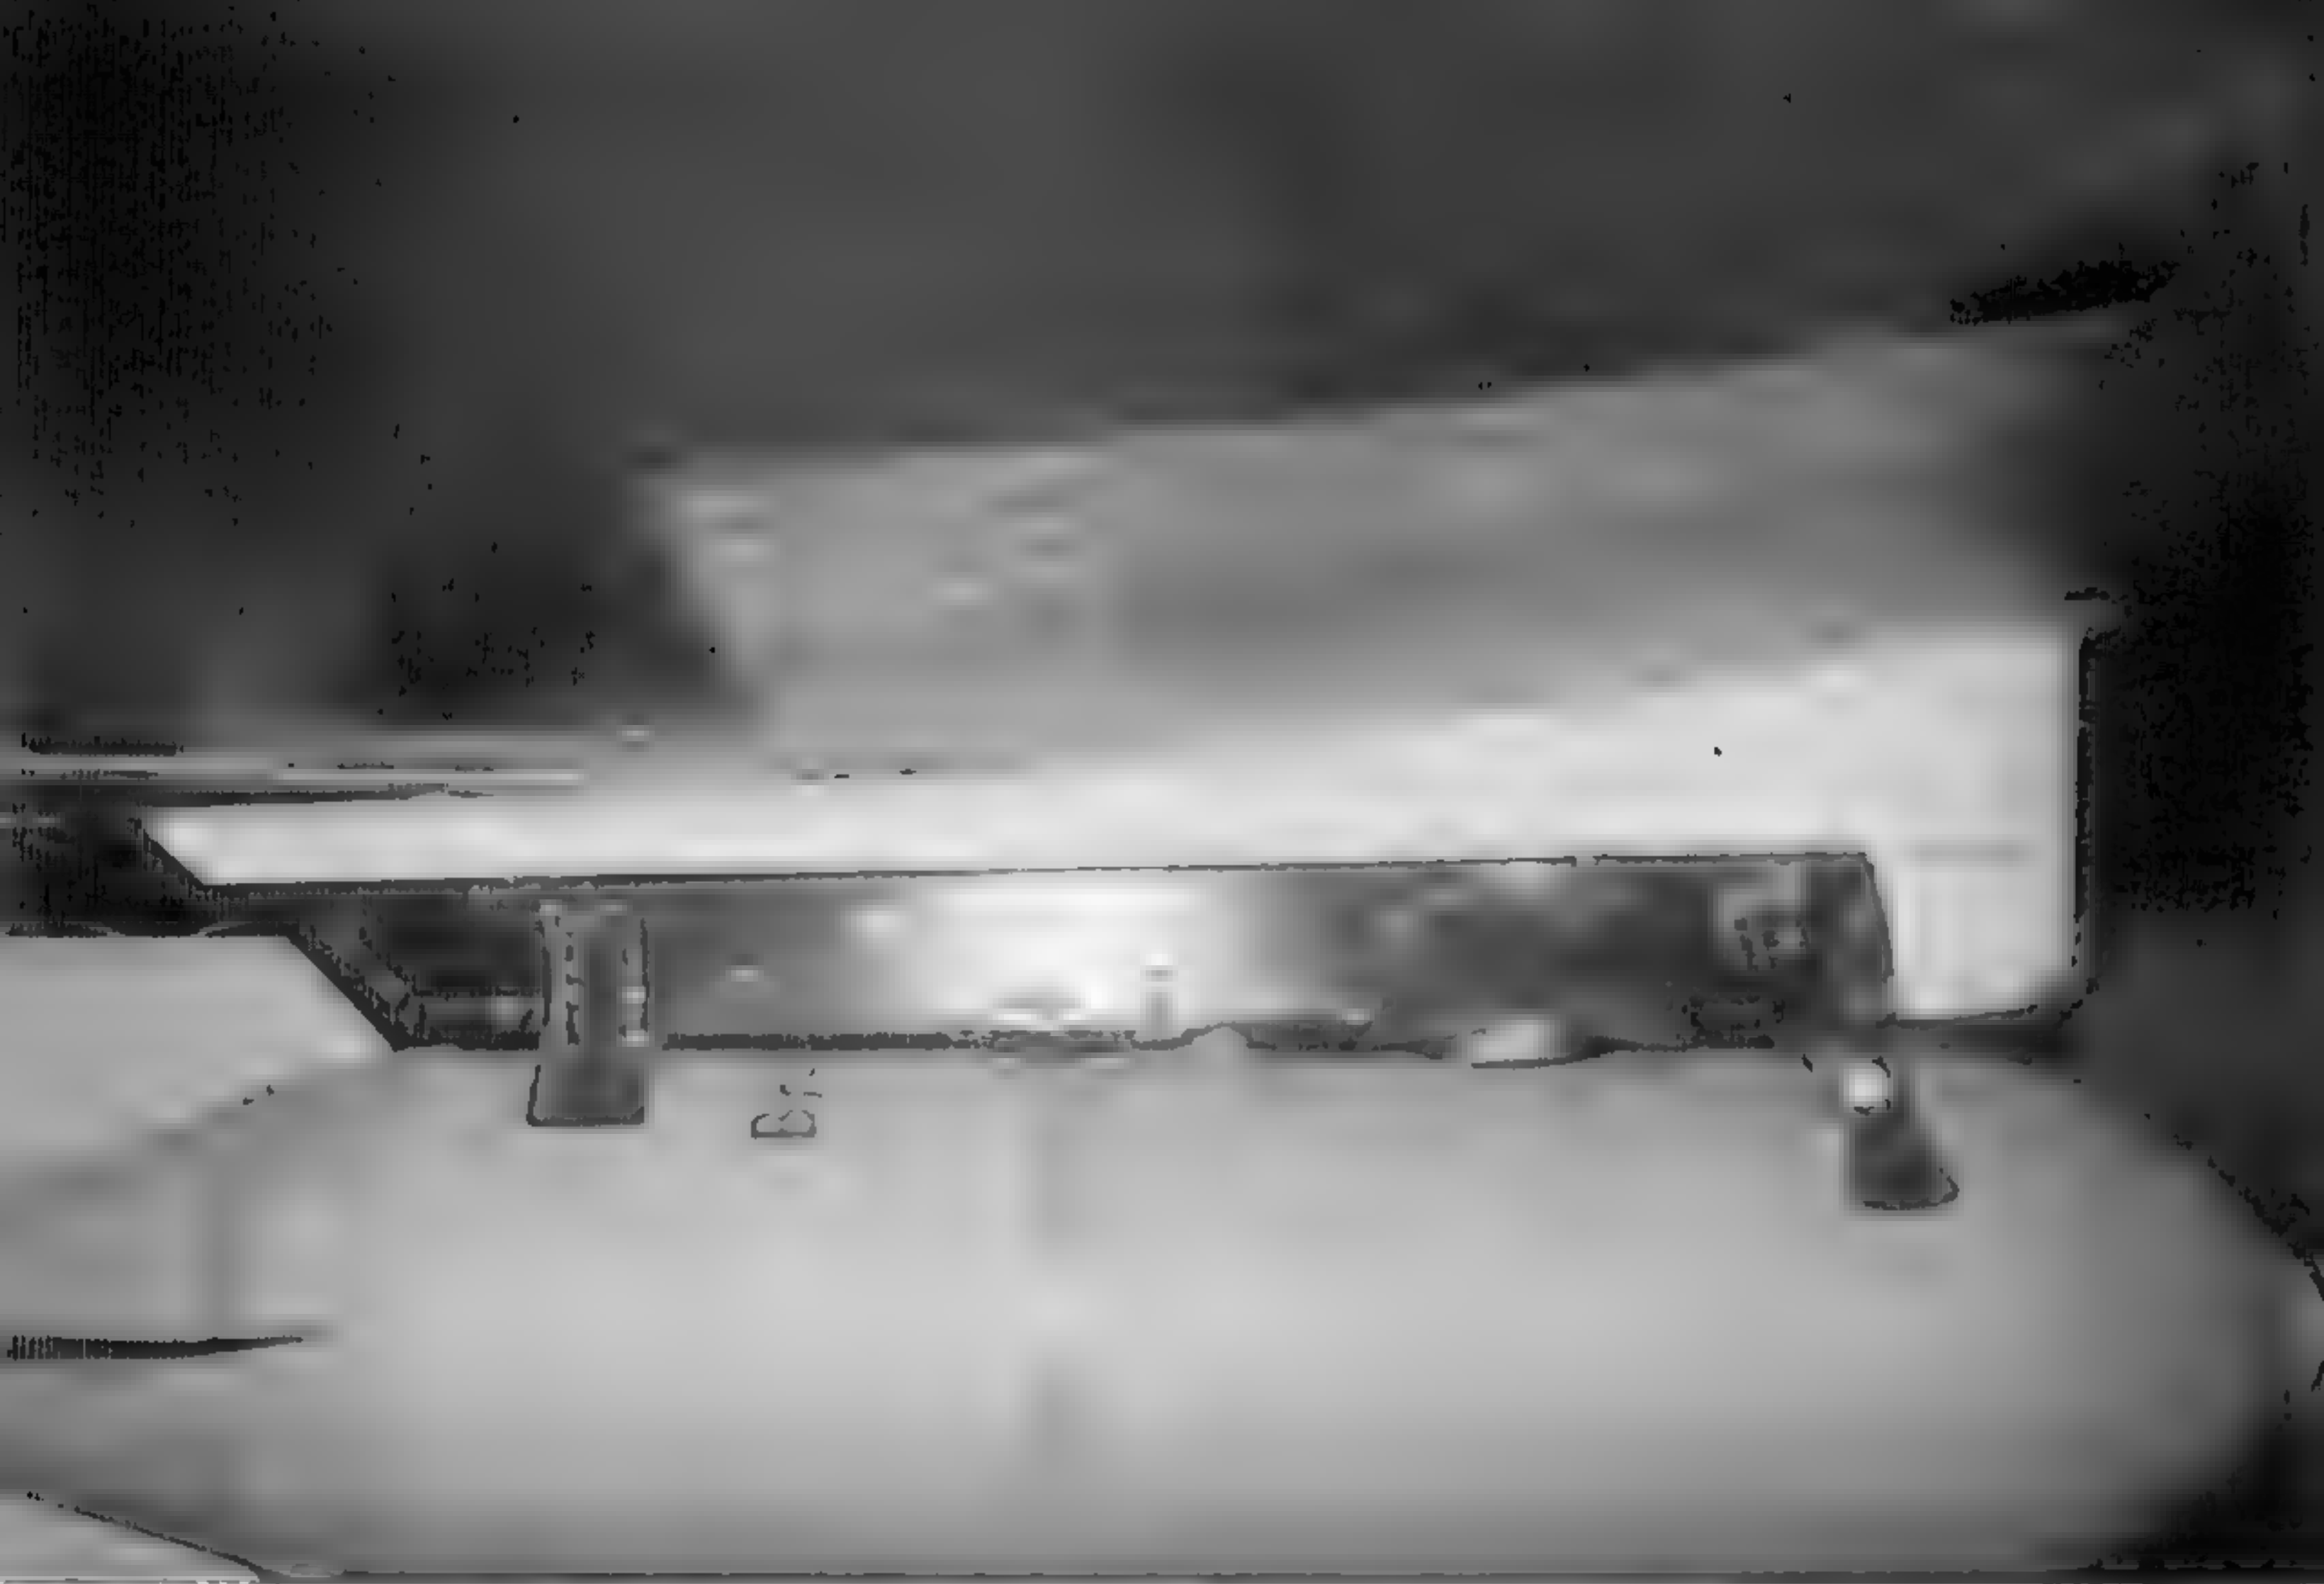
The ETC 50 bomb carrier unit and the swap braces securing the bomb to the rack are painted RLM 66 Black Gray (FS36081). The fairing is painted the wing under surface color of RLM 76 Light Blue (FS36473). The bombs were painted brown – a non-standard German ordnance color – with red bands and black stenciling. Late in the war, German aircraft bombs were painted in any color available to ground personnel. (Ryle)

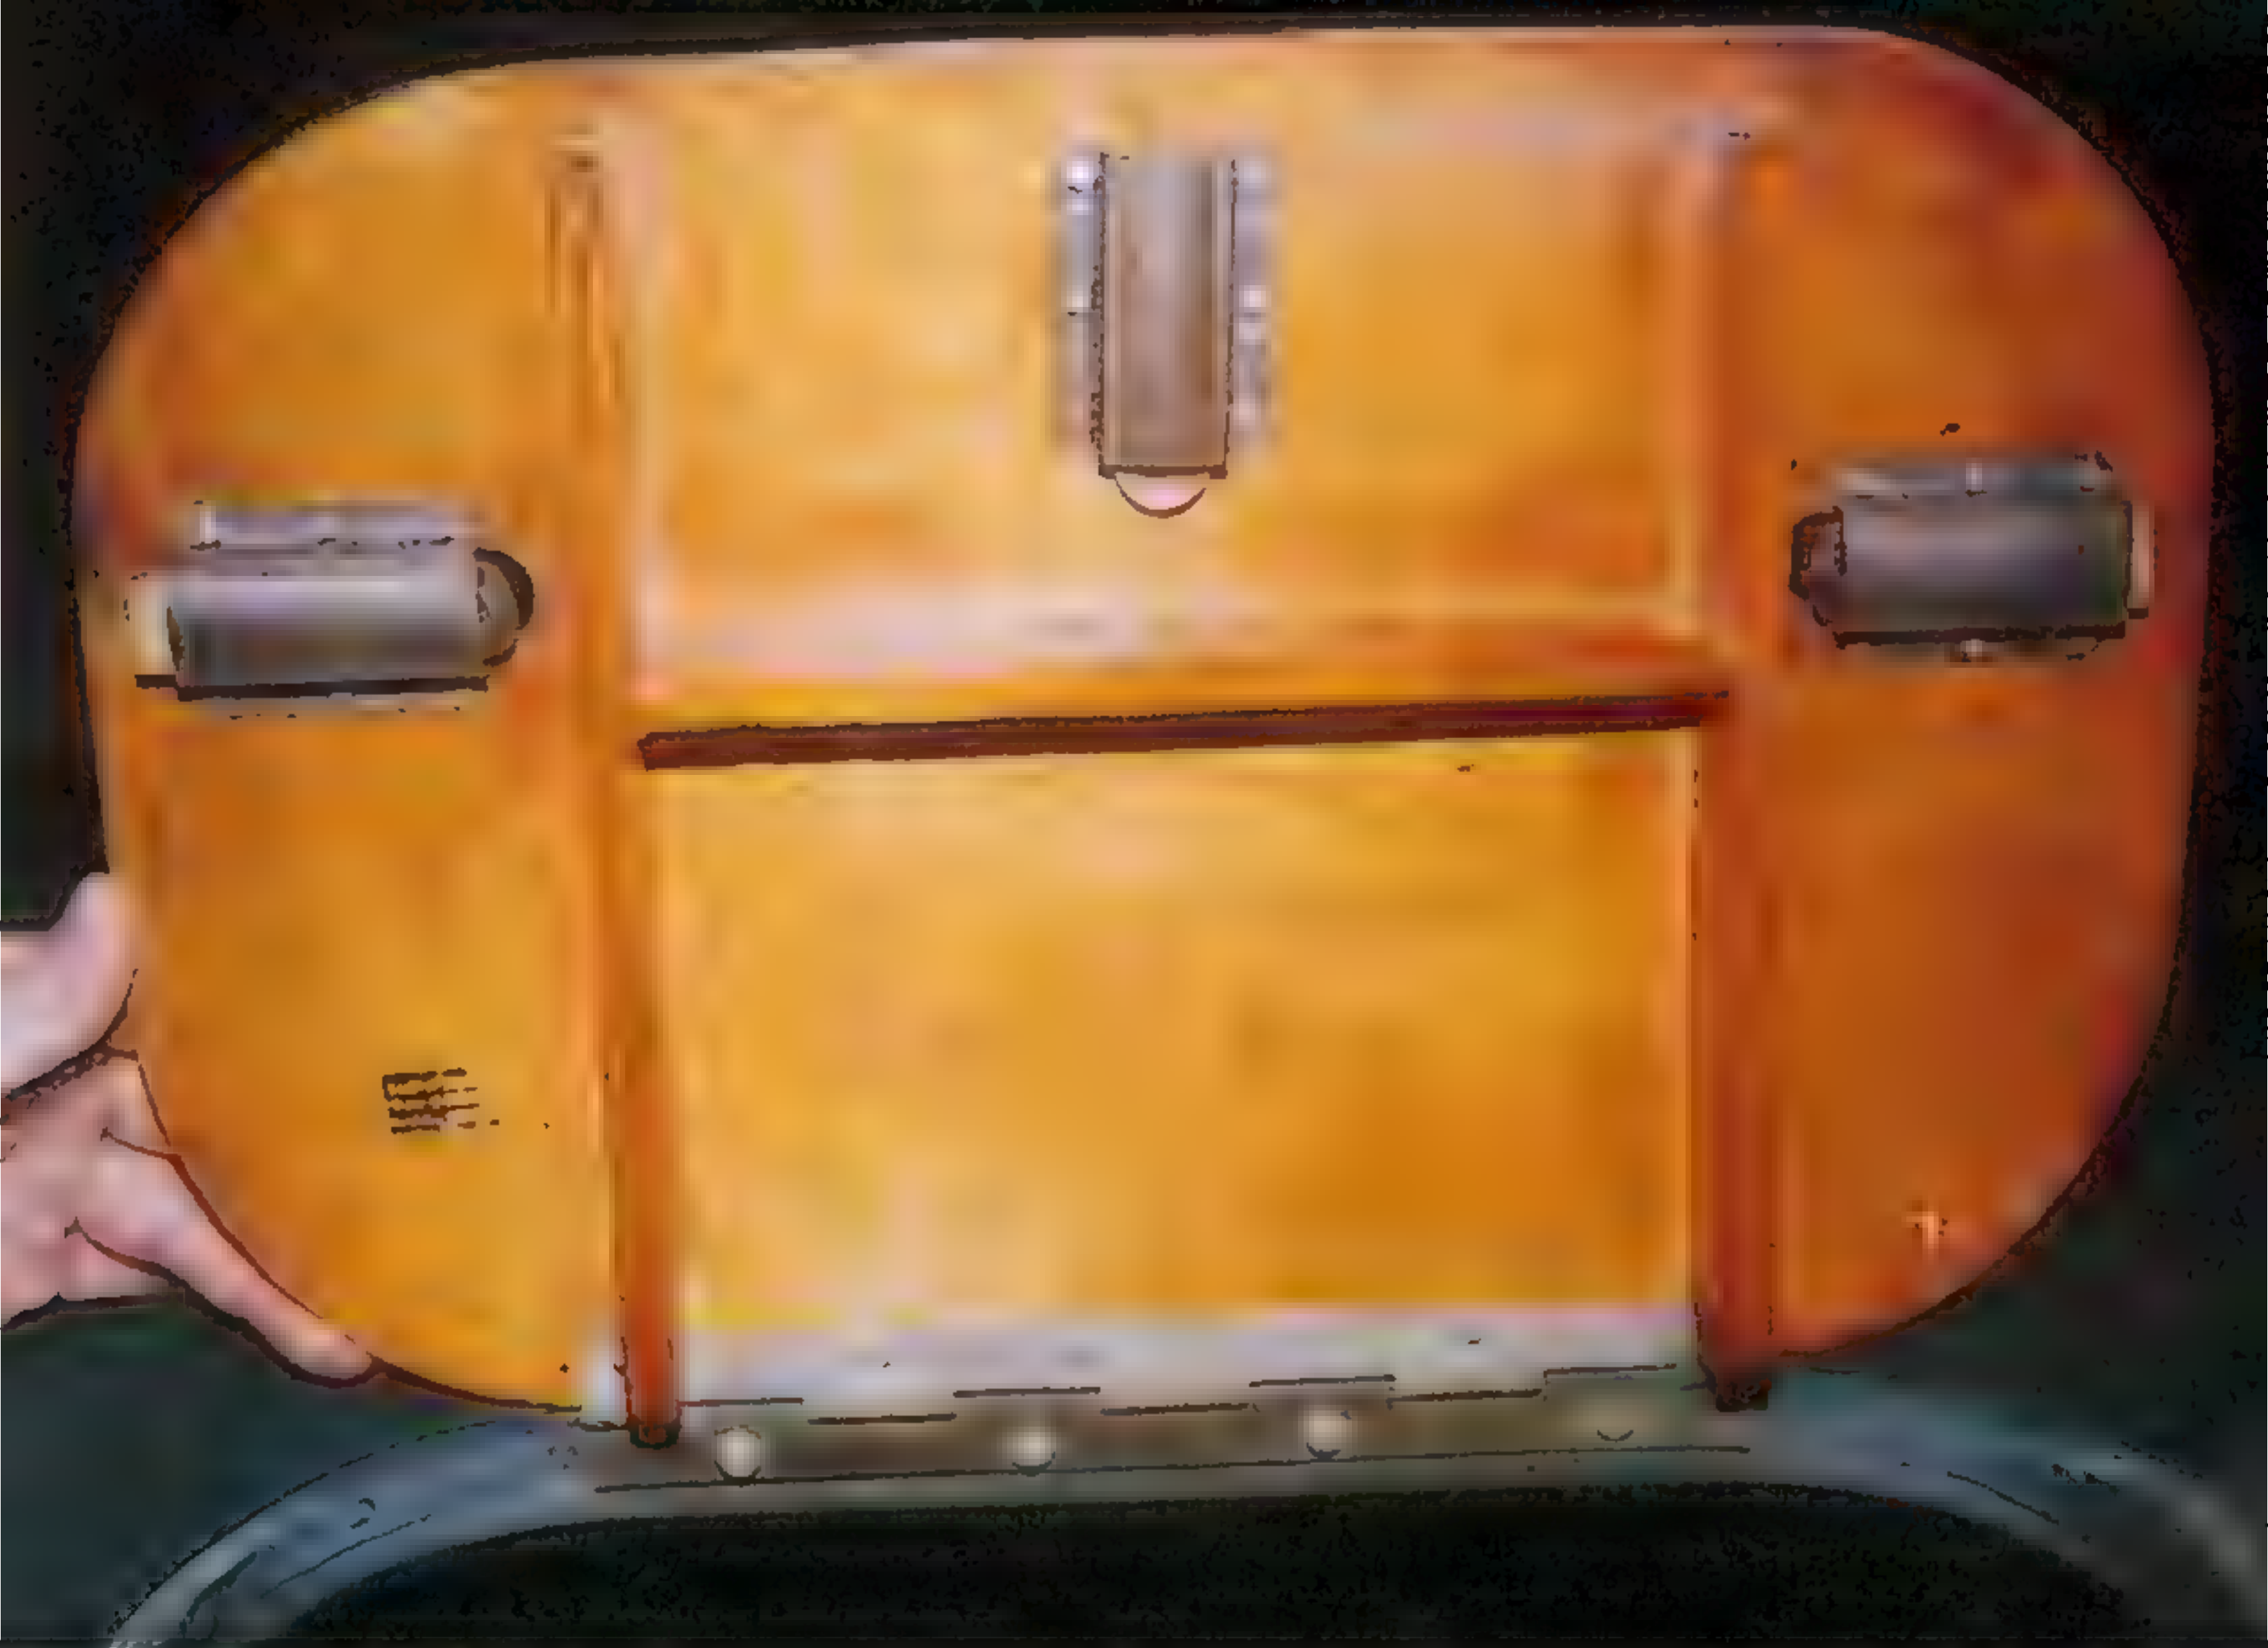
The inner shell of the radio compartment door was made of varnished wood due to the reduced availability of aluminum and other strategic materials in Germany late in World War II. The door's manufacturer affixed a small data tag decal to the aft side of the door interior. (Ryle)

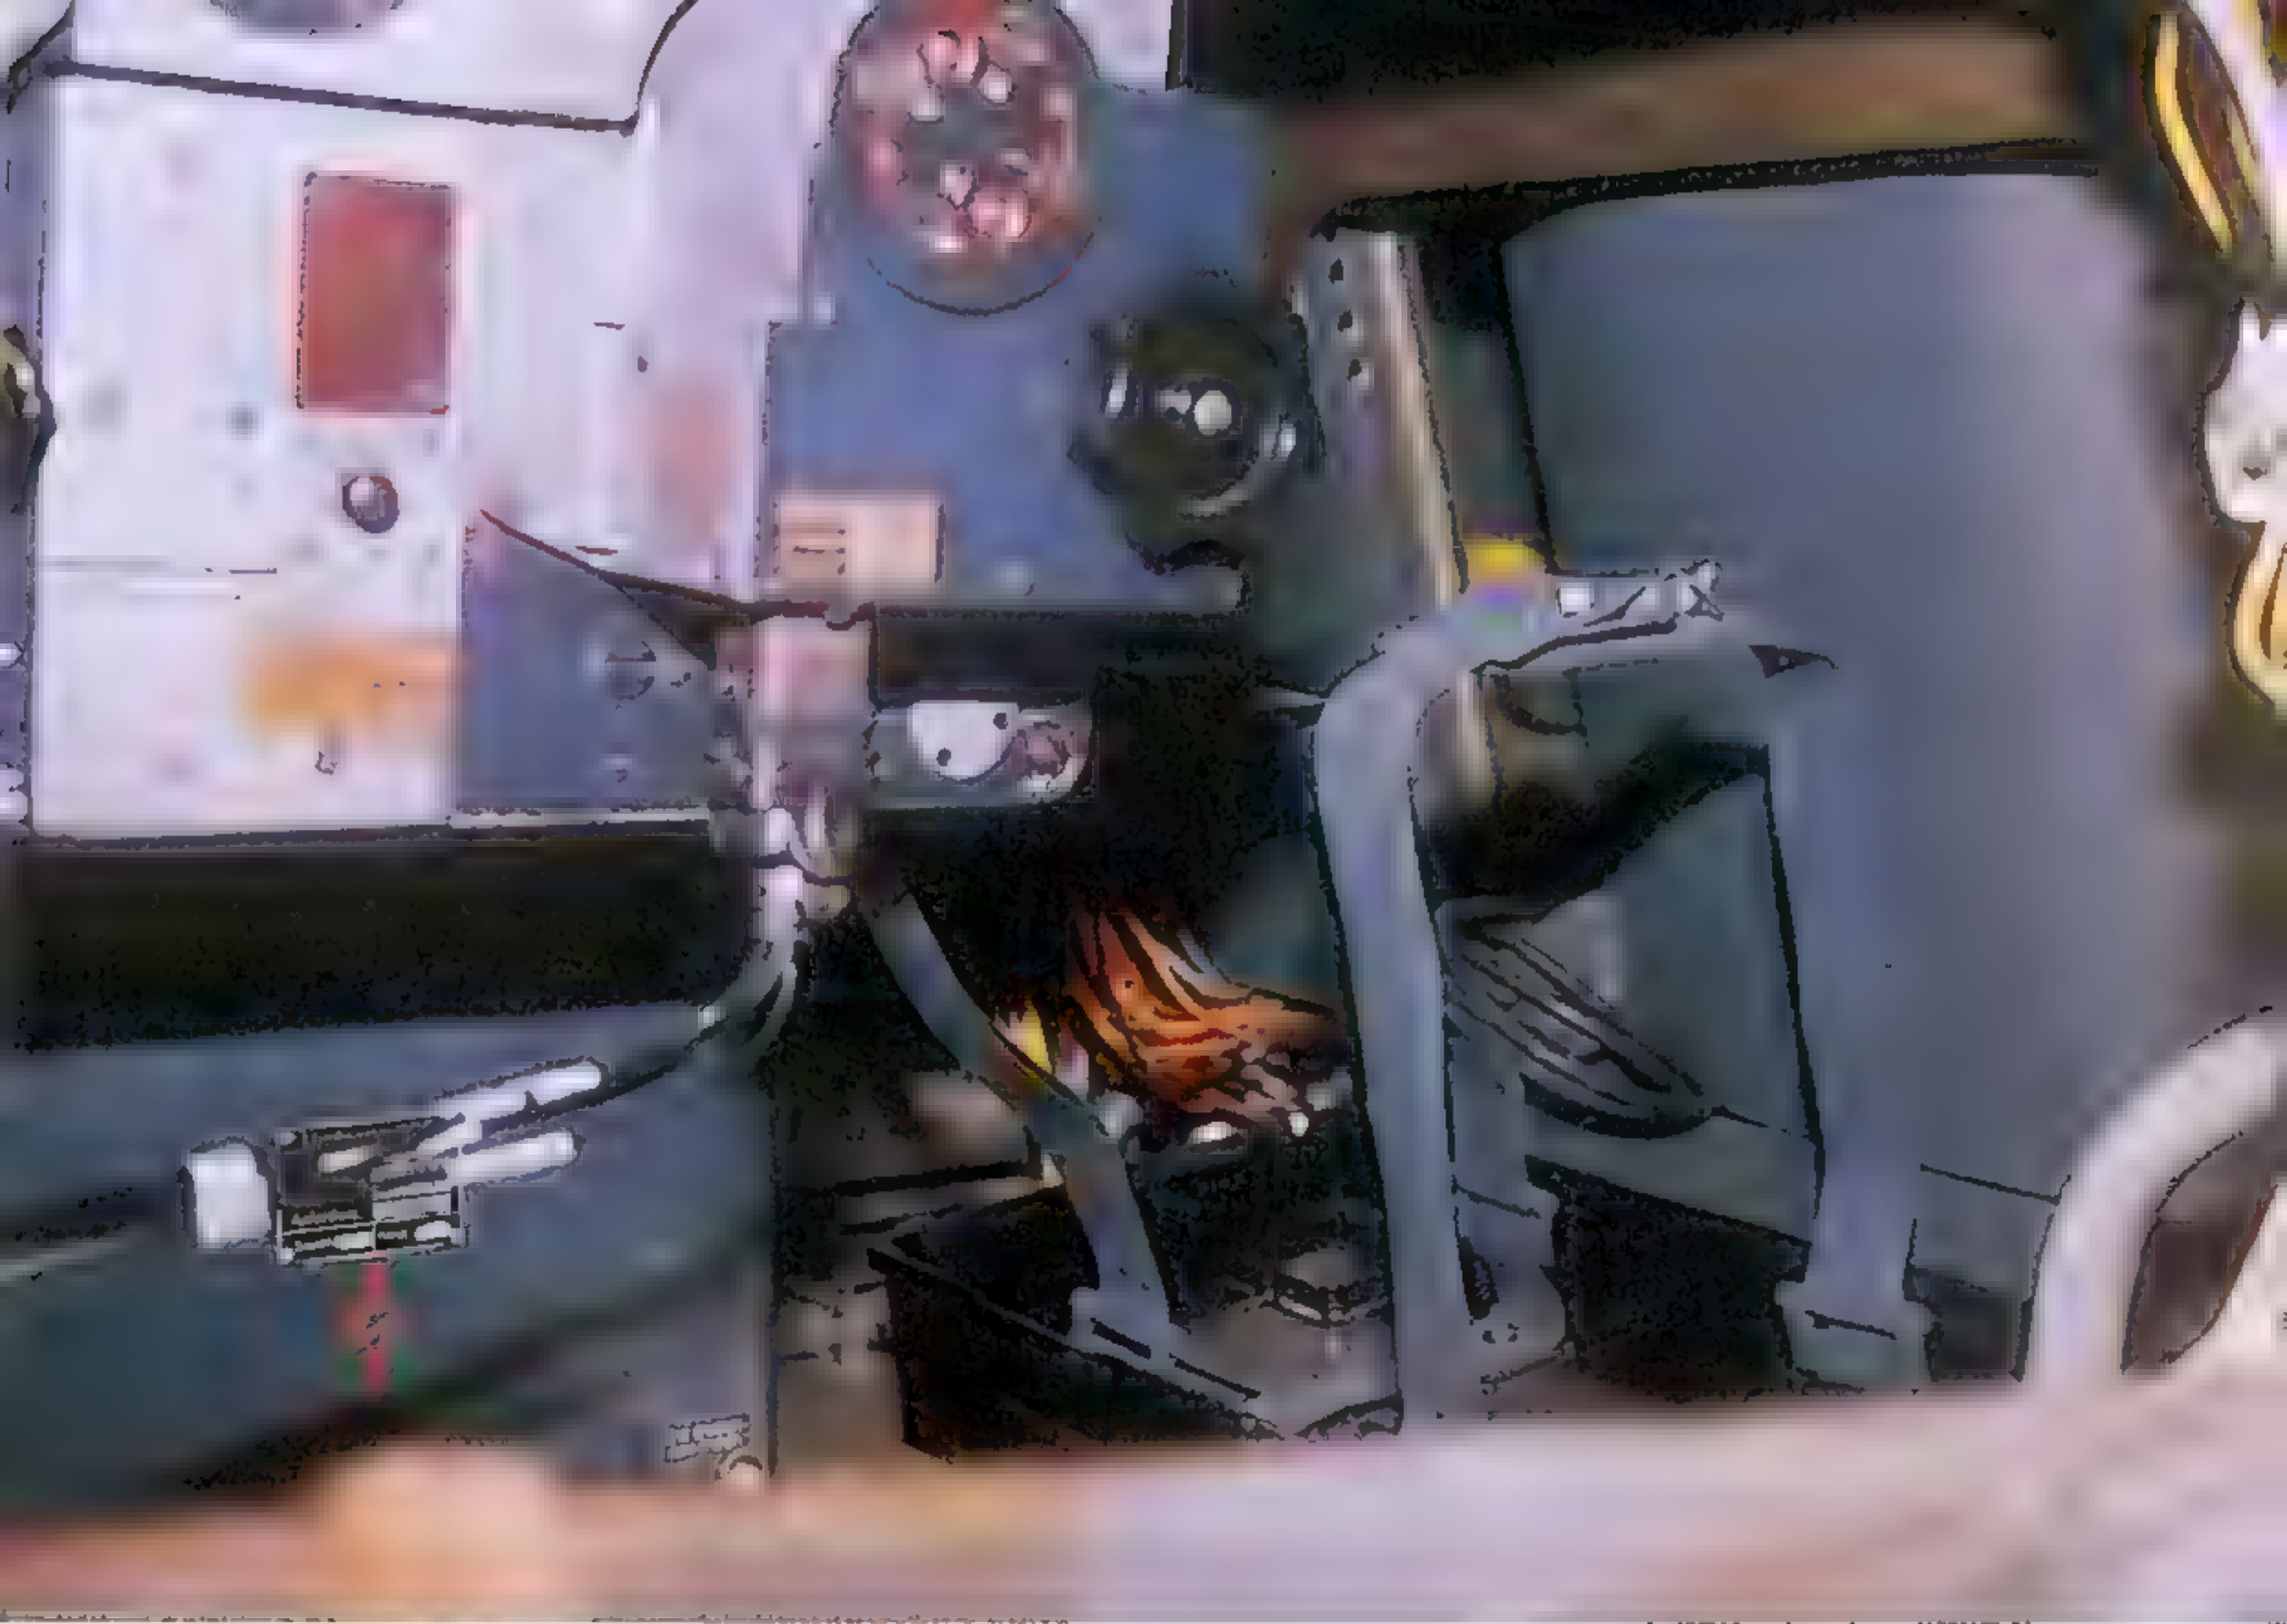
(Above) The FuG 16Z-S radio is placed immediately aft of the cockpit in the Fw 190F-8. The rear of the pilot's seat blocks off the front end of the radio compartment. Battery box hold-down straps are installed aft of the seat. The FuG 16Z-S was a VHF (Very High Frequency) radio for voice and radio homing communications and was used by ground attack pilots for both communications and target approach. (Ryle)

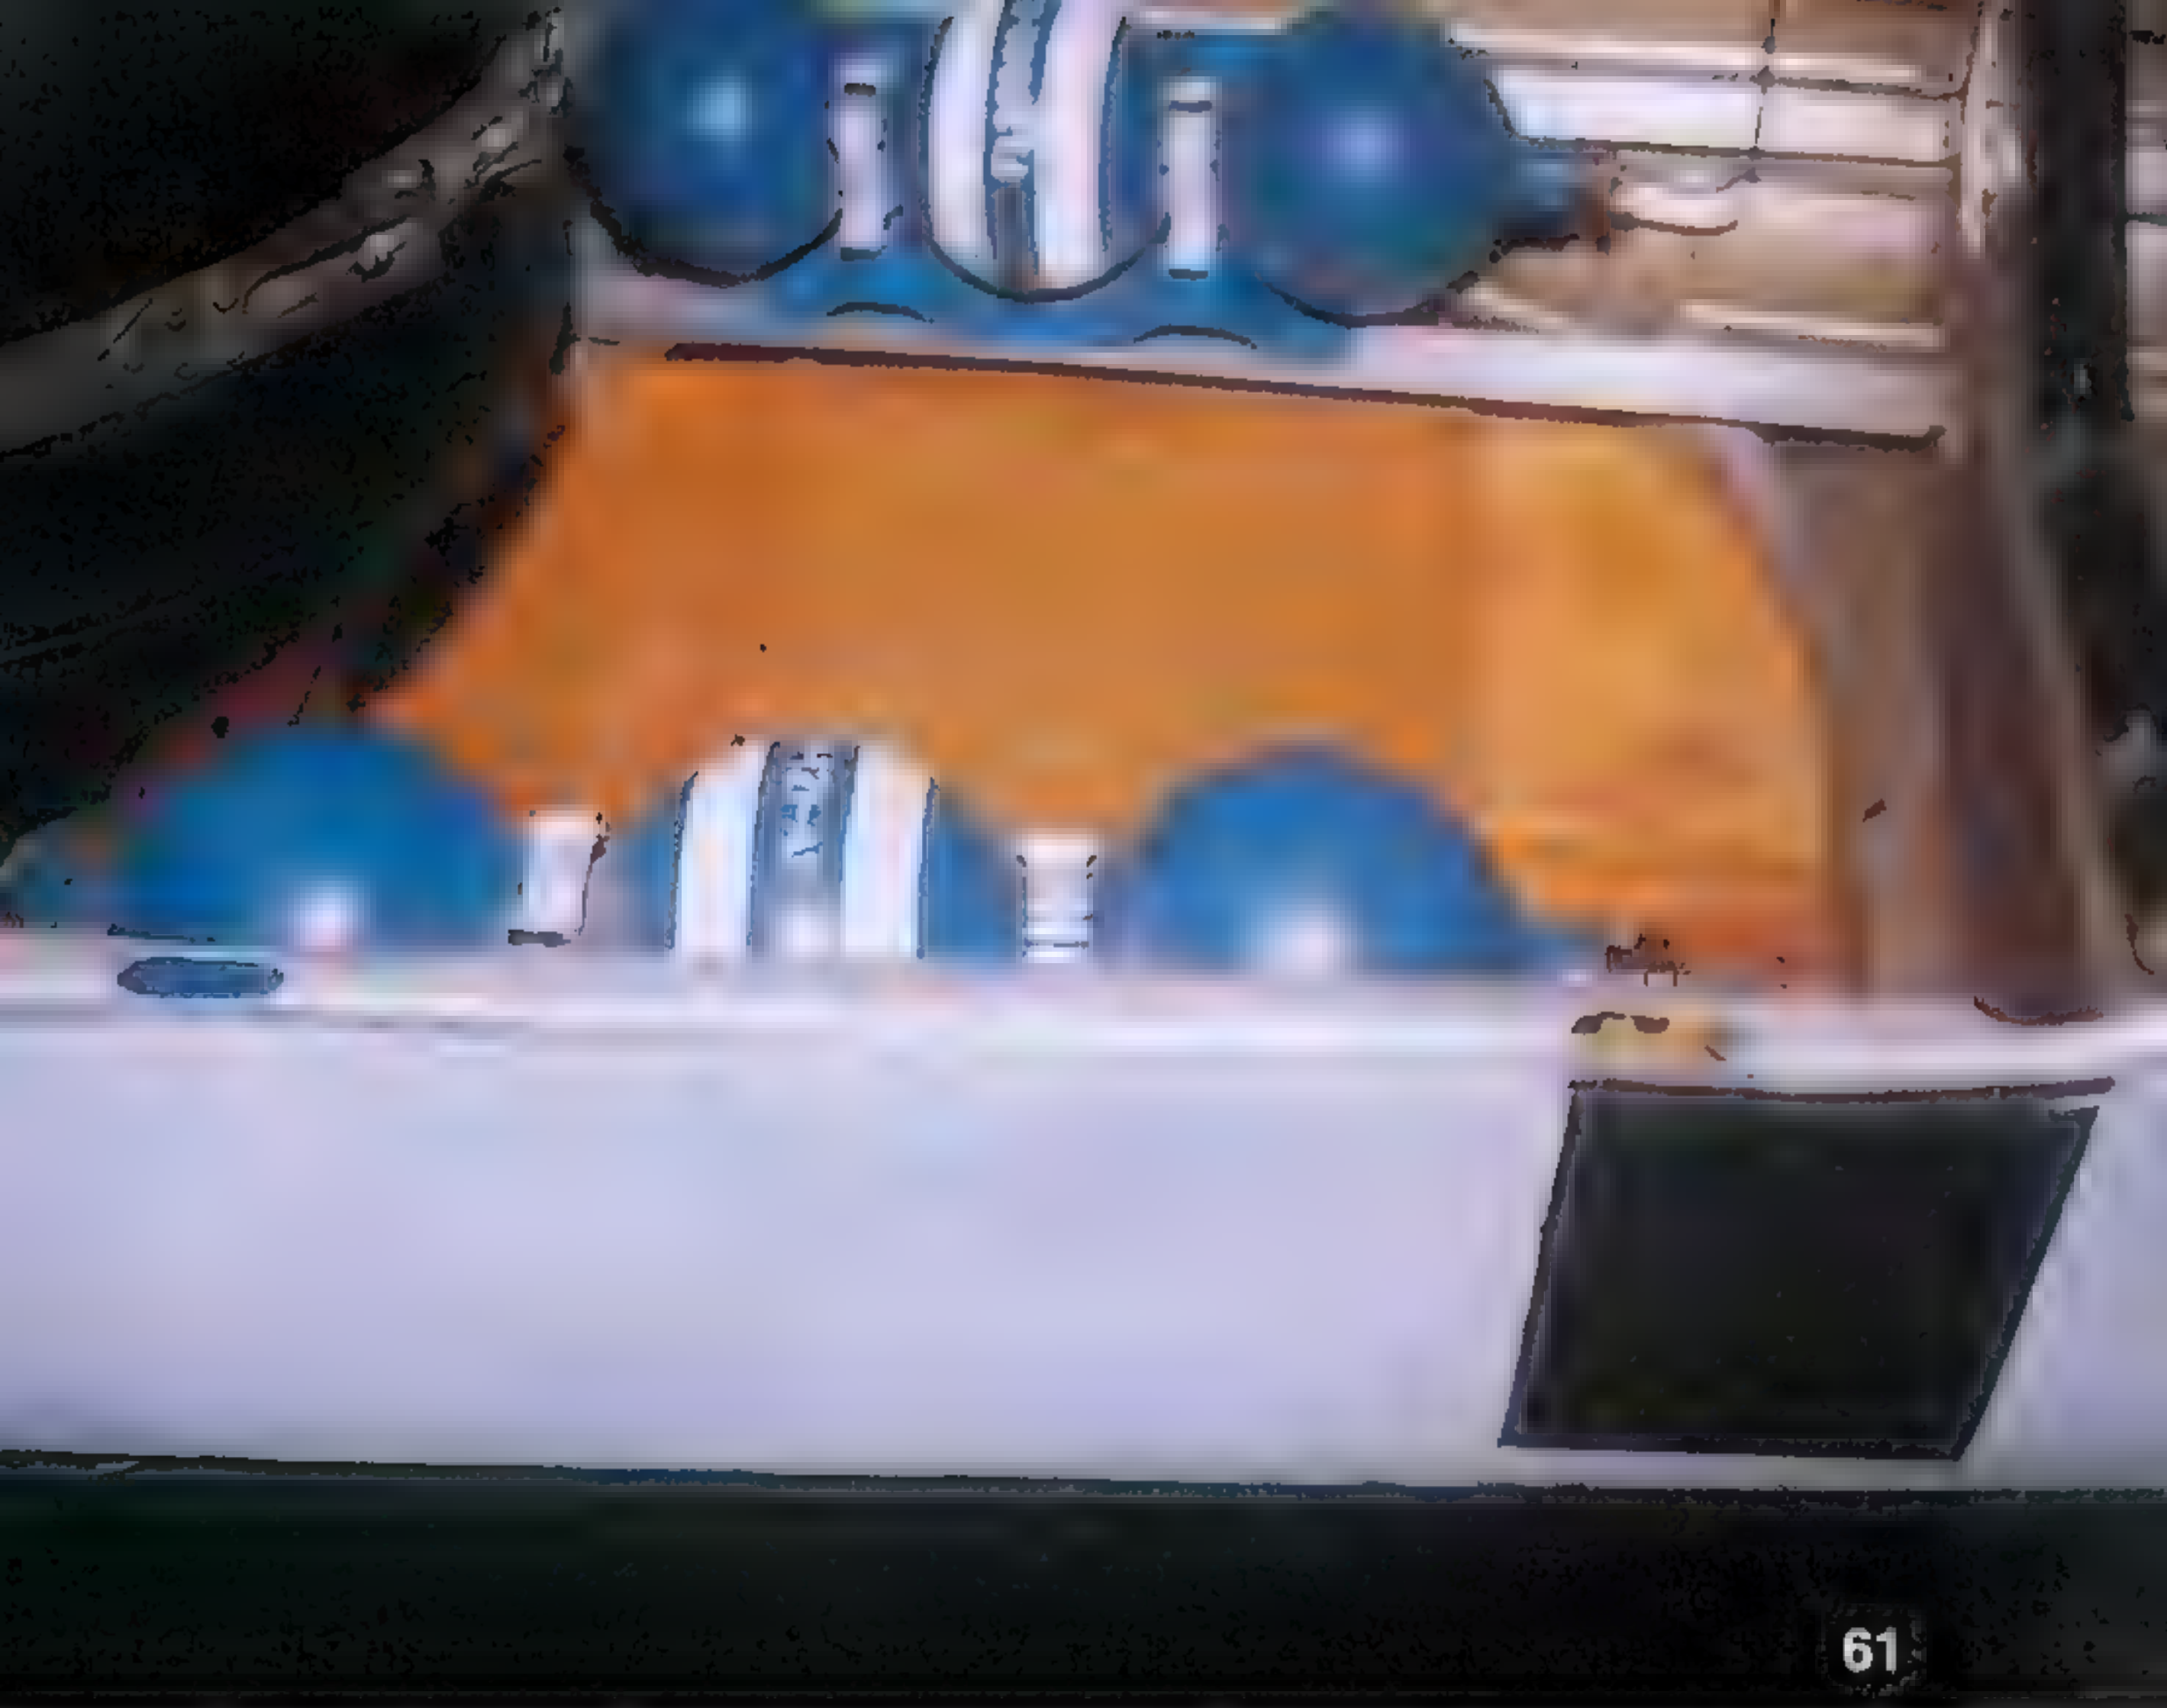
(Right) The Fw 190F-8's lower fuselage access panel was built with laminated wood – a common occurrence late in World War II, due to shortages in aluminum and other strategic materials. The auxiliary fuel tank is placed forward of the panel. Oxygen bottles were mounted alongside the port and starboard sides of this lower panel. Oxygen from these bottles was fed to the pilot's oxygen mask to enable the pilot to breathe at high altitudes. The fuselage interior was anodized to fight corrosion; however, it is not painted. (Ryle)
